“One on Two, and Two on One”: Preliminary results from a survey of dry stone walls on the National Trust Estate at Malham.

18. "ONE ON TWO, AND TWO ON ONE": PRELIMINARY RESULTS FROM A SURVEY OF DRY STONE WALLS ON THE NATIONAL TRUST ESTATE AT MALHAM

T C Lord

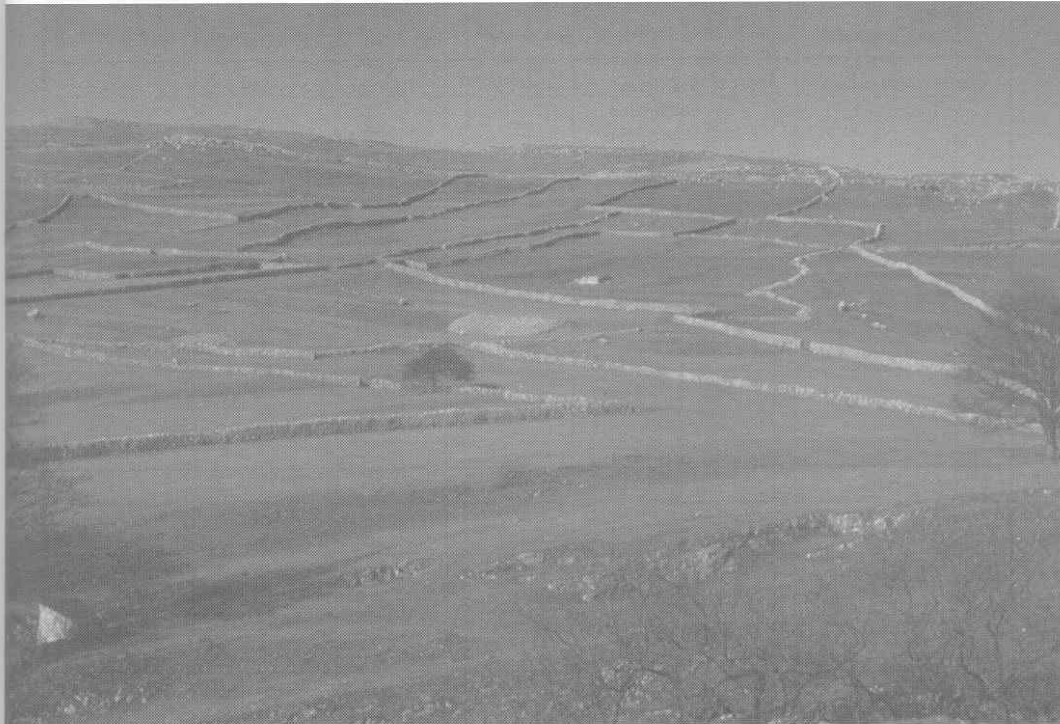
Figure 18.2. Piecemeal enclosure in the former Malham infield. Narrow top wide base walls and stone dumps with plough scratched stones.

Narrow-top double walls with a broad base occur in the former village infield south east of Malham Cove. The face stones in these walls are mostly rounded stones described in the survey as cobbles. They derive from the local glacial drift and were probably brought to the surface by ploughing. The infield at Malham contains numerous grassed over lynchet banks and plough strips. Several plough-scratched stones, built into the infield walls or lying on adjacent stone heaps, were noted. Fine scratches were possibly made by an iron coulter, the vertical cutting knife fitted in front of the plough share. The scratches are nearly always parallel to each other which suggests the plough team repeatedly ploughed along the same axis. This is consistent with the dimensions of the plough lands which are basically too narrow to permit transverse ploughing. One stone observed on a dump had more than twenty parallel scratches.

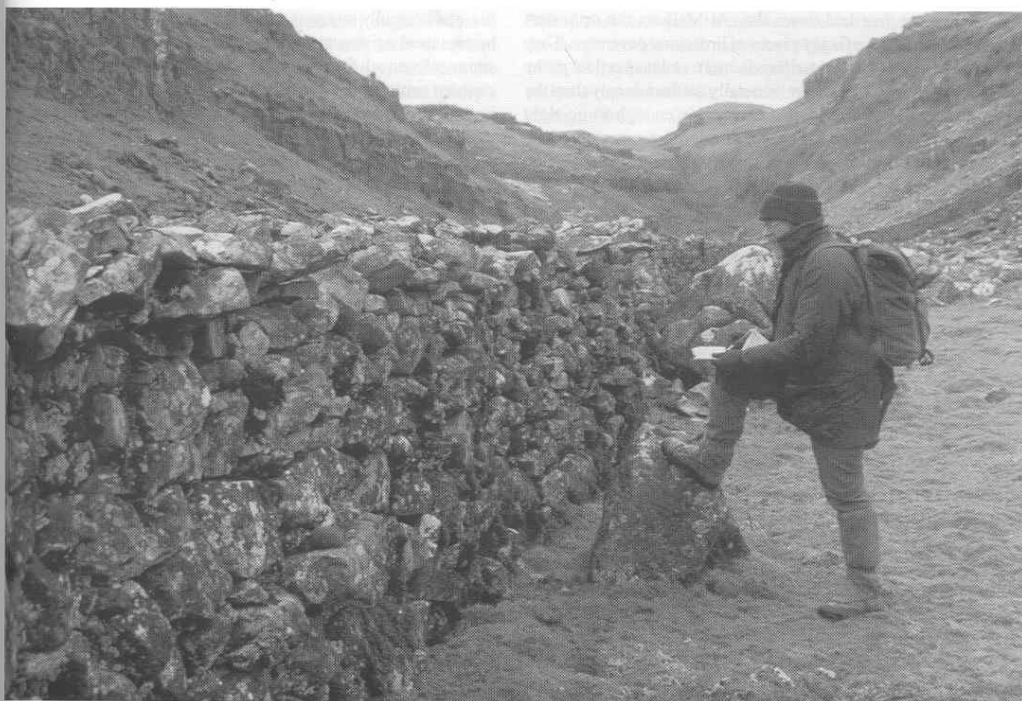
Figure 18.4. Wide top double wall with projecting topstones in the Watlowes dry valley.

Wide-top walls with projecting top stones were originally built 1.6m to 1.8m high. With a width at base of 70-80cm, and a width beneath the coping of 50cm, they were often constructed with very little batter, and have a nearly vertical profile. With the addition of a continuous lip projecting some 15cm on the top of one side of the wall, this side must have presented a considerable obstacle to a jumping animal. These wide-top walls exhibit other distinctive structural characteristics.

Fragments of overhanging coping still survive on the wide-top wall running the length of the boulder strewn floor of Watlowes, the dramatic dry valley above Malham Cove (Fig 18.5). A post-Dissolution dispute about grazing in 1569 refers to this boundary as the western limit of Bolton Priory's grazing. Significantly the boundary was not the subject of the dispute which was about who had rights to graze the "Prior Raike" (Morkill 1933, 66). The wide-top wall with projecting top stones continues northwards, beyond the head of Watlowes, as far as sink holes for the overflow stream from Malham Tarn. At this point the sub-strate becomes less favourable for wall preservation, and there is evidence of extensive re-walling.

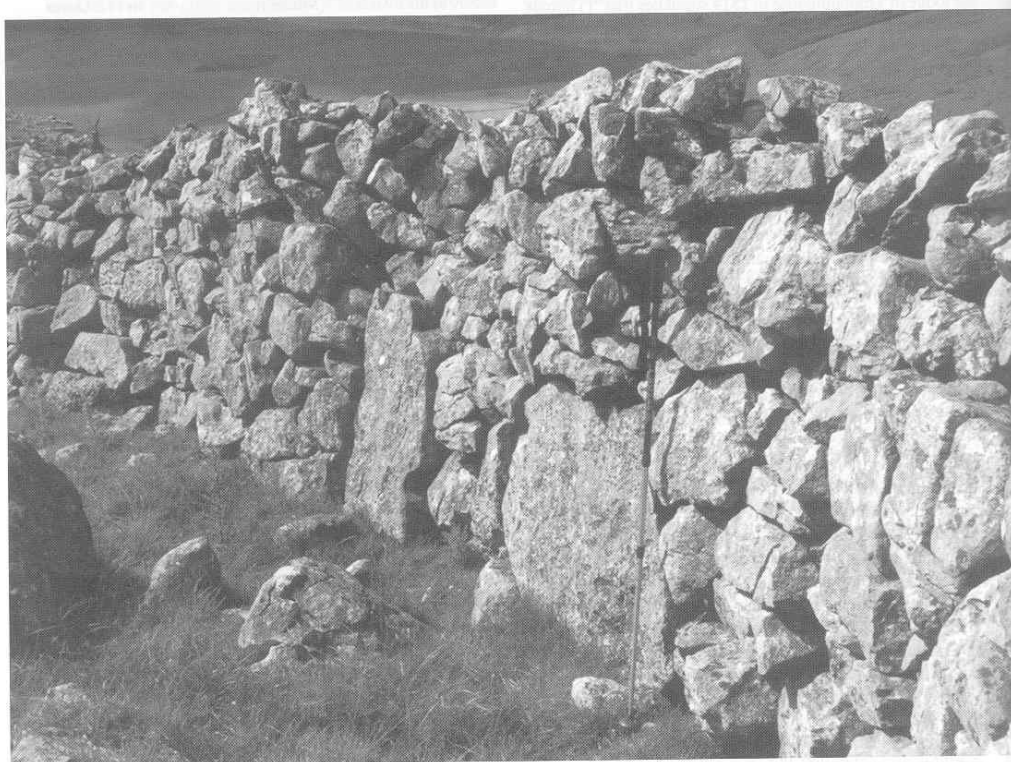
Figure 18.5. Orthostats at the base of a wide top double wall near Darnbrook. The original topstones are missing.

Firstly, large stones occur high up in the wall, because the greater width of the wall requires much deeper face stones laid end in, end out, to reach into the heart of the wall. This results in the face stones appearing much less sorted for size than in narrow-top walls. Secondly, straight joints, considered a defect in narrow-top walls, are fairly common. A straight joint is formed where a face stone fails to cross the vertical gap between two underlying stones. It seems that the builders of wide-top walls relied far more on the binding properties of large stones laid end in, end out, rather than crossing the joints between the face stones, as is the case in narrow-top walls. Thirdly, the footings invariably include orthostats (Fig 18.5).

An orthostat is a large slab-like stone placed on its side or even on end, rather like a playing card stood on one

side rather than laid down flat. At Malham the orthostats are nearly always flaggy pieces of limestone pavement. They are placed so their outer face is more or less vertical at the foot of the wall. They are generally set less deeply than the adjacent footings, and are rarely wide enough to go right through a double wall. Orthostats might be expected where especially deep footings go nearly through the wall and reduce the space for the opposite row of footings. But this does not seem to be the case. It is usual to find the space immediately behind the inner face of an orthostat packed with large fillings. Moreover it is not uncommon to find orthostats placed directly opposite each other. In these instances there may be a through running the width of the wall resting directly on top of each orthostat. This creates a box-like structure at the base of the wall, probably intended to bind the tops of the orthostats into the face of the wall and reduce the tendency for them to be displaced outwards. Orthostats usually occur singly, but sometimes two or more may be placed next to each other.

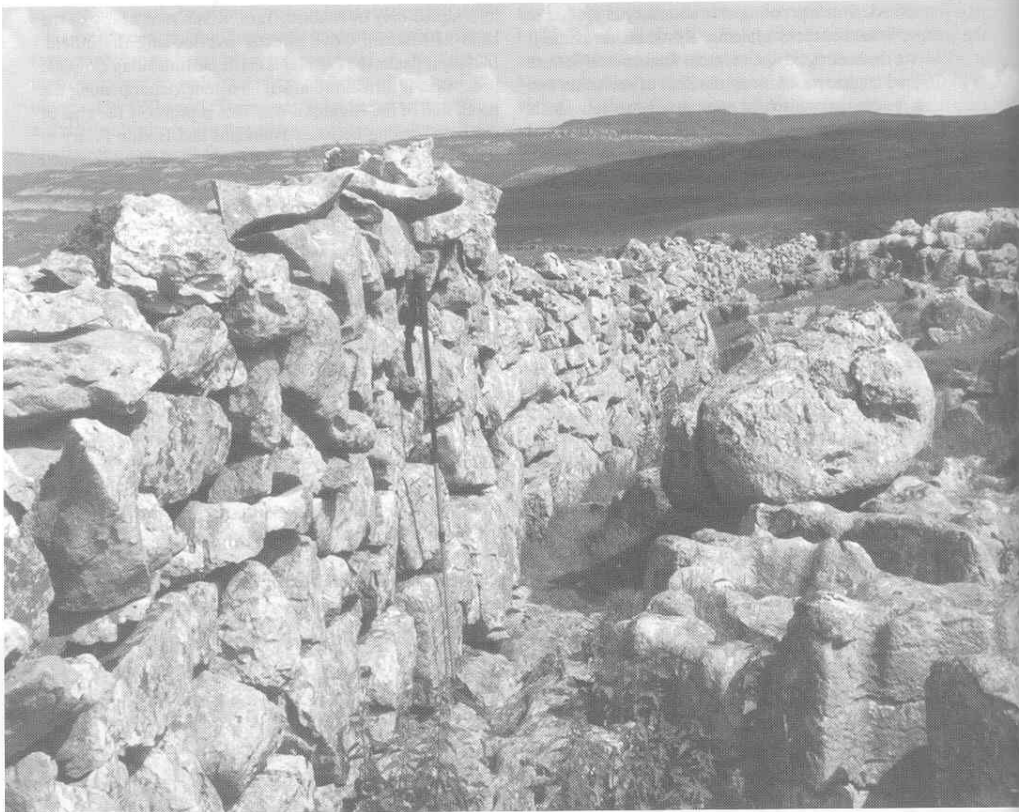
Figure 18.6. Wide top double wall with projecting topstones built on limestone pavement near Darnbrook.

The wide-top wall with overhanging coping on the south side of Darnbrook gill (Fig 18.6) is part of a wall line,
